YOUR INSPECTION REPORT

1234 Maple Street
Ottawa, ON

Wednesday, September 3, 2014

Report No. 1710, v.2

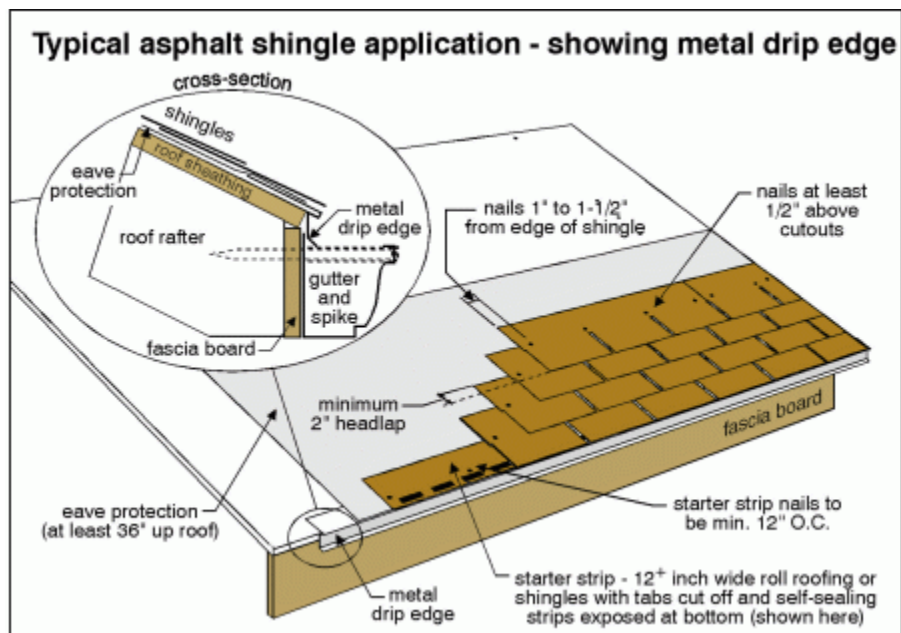
2. **Condition:** • [Old, worn out](#)

The shingles need to be replaced on the storage shed.

Implication(s): Chance of water damage to contents, finishes and/or structure

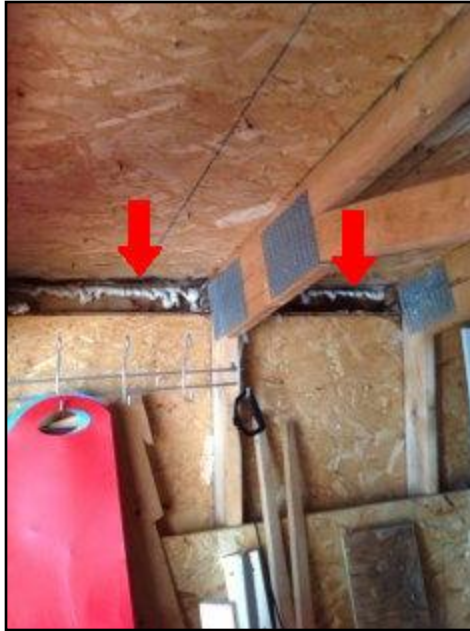
1. *Missing*

3. **Condition:** • [Missing](#)

There is some leakage at the eaves in the storage shed. Some roof sheathing has rotted and needs to be replaced. Also, there should be a drip edge flashing to direct water away from the roof sheathing as discussed.

Implication(s): Chance of water damage to contents, finishes and/or structure

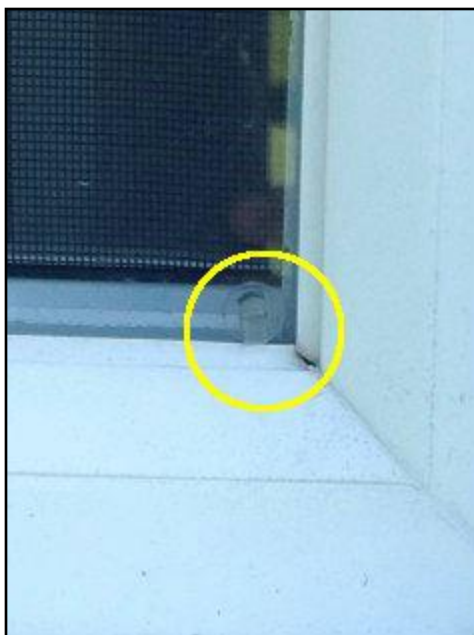
4.

5. **Condition:** • All exterior windows and doors are original. Some have been repaired to eliminate condensation between the panes of glass (broken thermal seals.)

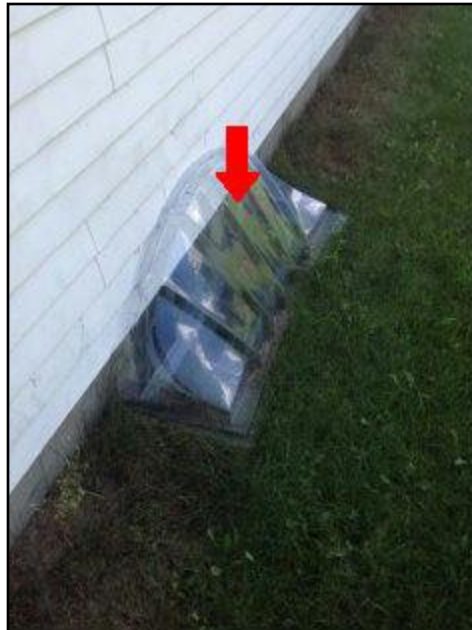
6. **Condition:** • Quite often window well covers are not installed until there has been a leak around the basement window. There were no signs of leakage inside.

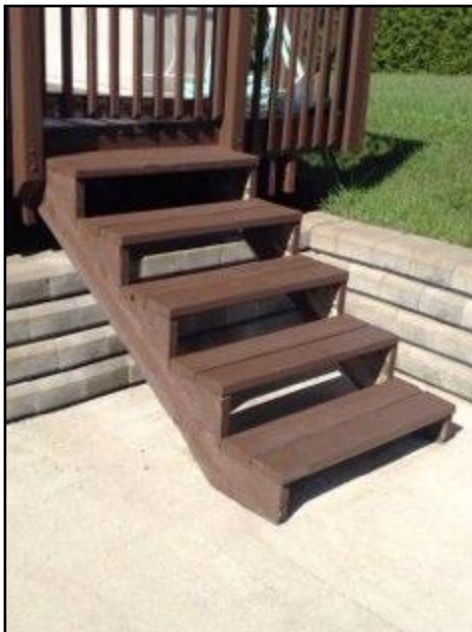
7. Missing

7. Condition: • [Missing](#)

Implication(s): Fall hazard

Task: Provide

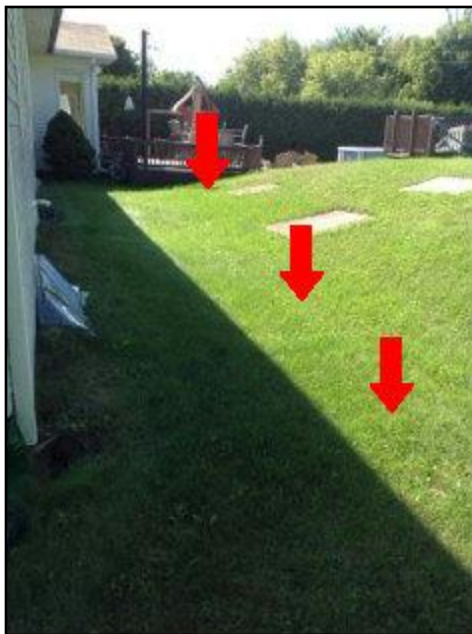
8. *Improper slope*

8. Condition: • [Improper slope](#)

Implication(s): Chance of water damage to contents, finishes and/or structure

Task: Improve

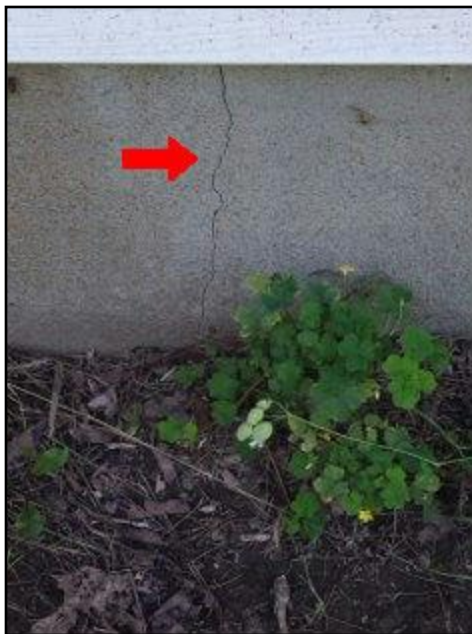
10. Typical minor cracks

9. Condition: • Typical minor cracks

These are typical minor settlement cracks in the foundation wall. Reparge from the exterior and monitor. This is not a structural concern and there is no visible signs of leakage on the inside.

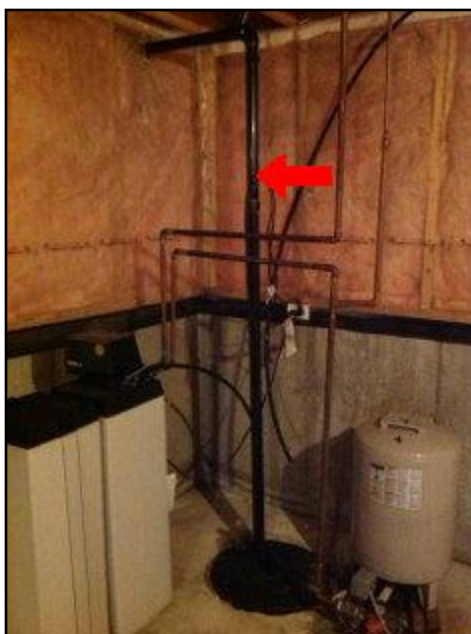
15. Missing check valve

14. Condition: • [Missing check valve](#)

Implication(s): Reduced operability

Task: Provide

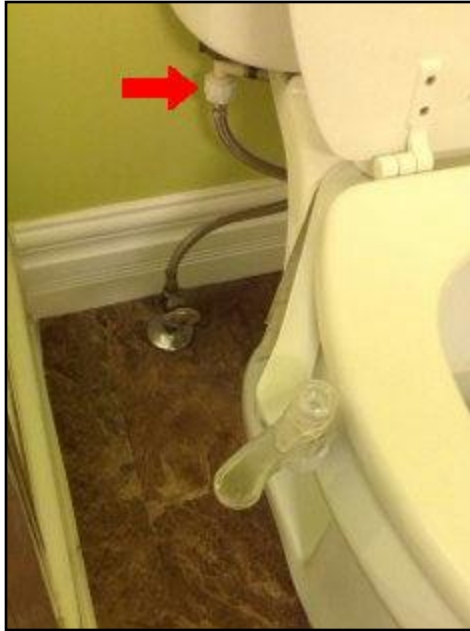
16. *Backflow prevention missing*

15. Condition: • Backflow prevention missing

Implication(s): Contaminated drinking water

Task: Repair or replace

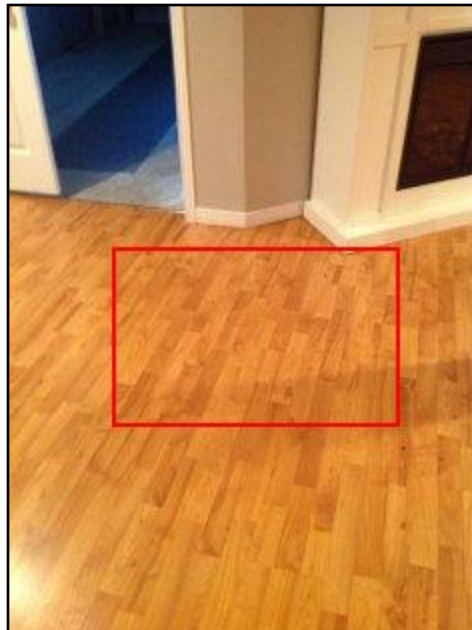
17. Buckled

16. Condition: • [Buckled](#)
Implication(s): Cosmetic defects | Trip or fall hazard
Location: Basement Family Room
Task: Further evaluation
Time: Immediate
