YOUR INSPECTION REPORT

1234 Maple Street
Ottawa, ON

Wednesday, September 3, 2014

Report No. 1710, v.2

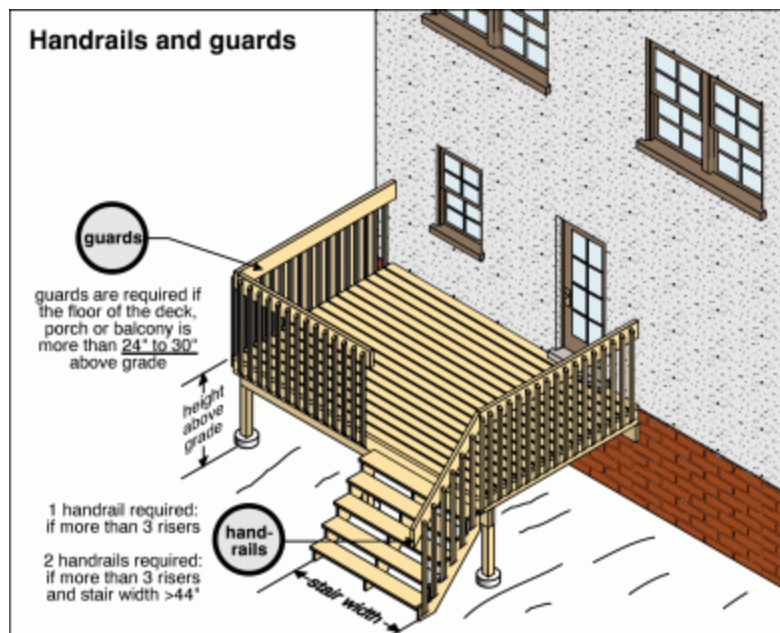
7. Missing

7. Condition: • [Missing](#)

Implication(s): Fall hazard

Task: Provide

Time: Immediate

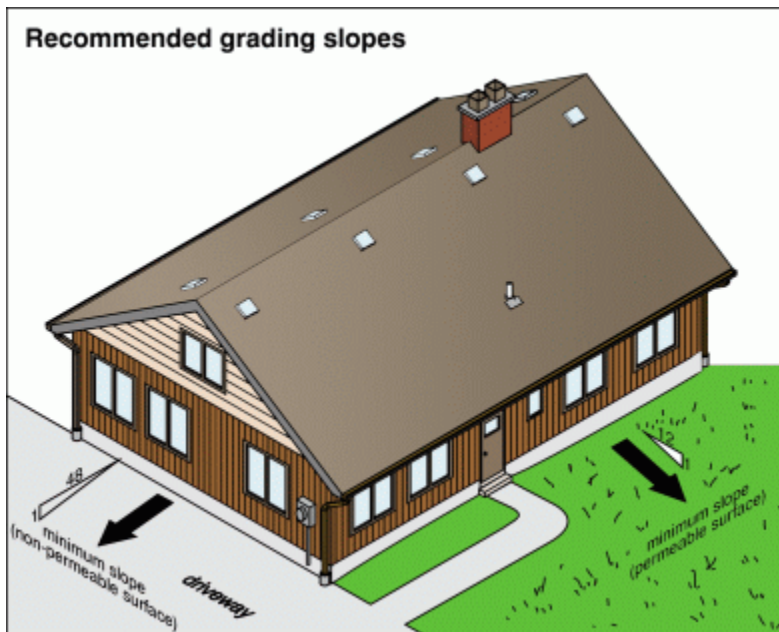
8. *Improper slope*

8. Condition: • [Improper slope](#)

Implication(s): Chance of water damage to contents, finishes and/or structure

Task: Improve

Time: Discretionary
